MERRIMACK RIVER BASIN
BRADFORD, NEW HAMPSHIRE

TODD LAKE DAM

NH 00288

PHASE I INSPECTION REPORT
NATIONAL DAM INSPECTION PROGRAM

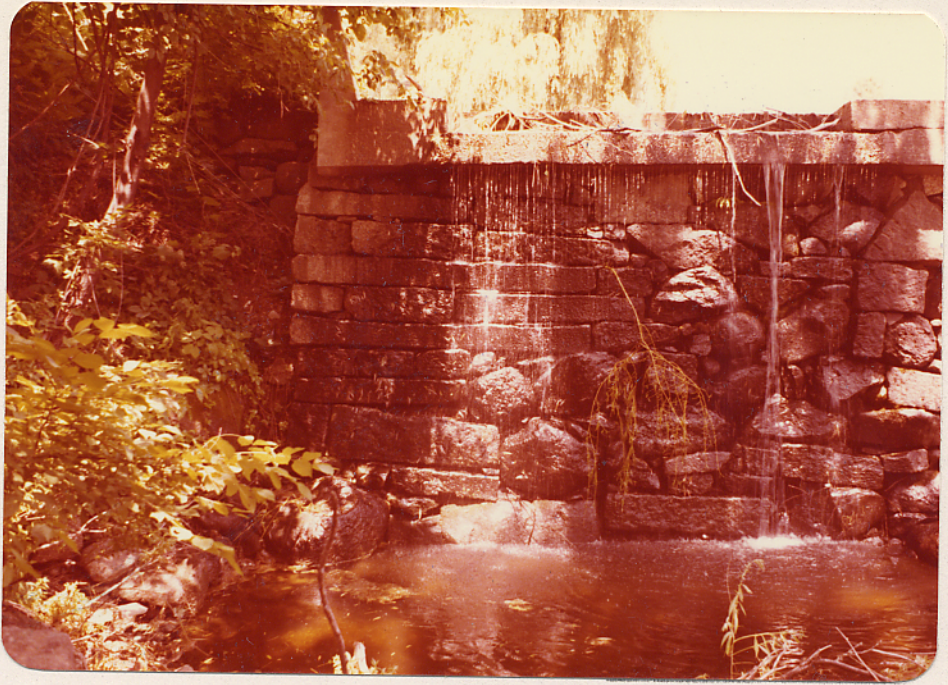
1. View of right abutment and right side of spillway from downstream (8 July 78)

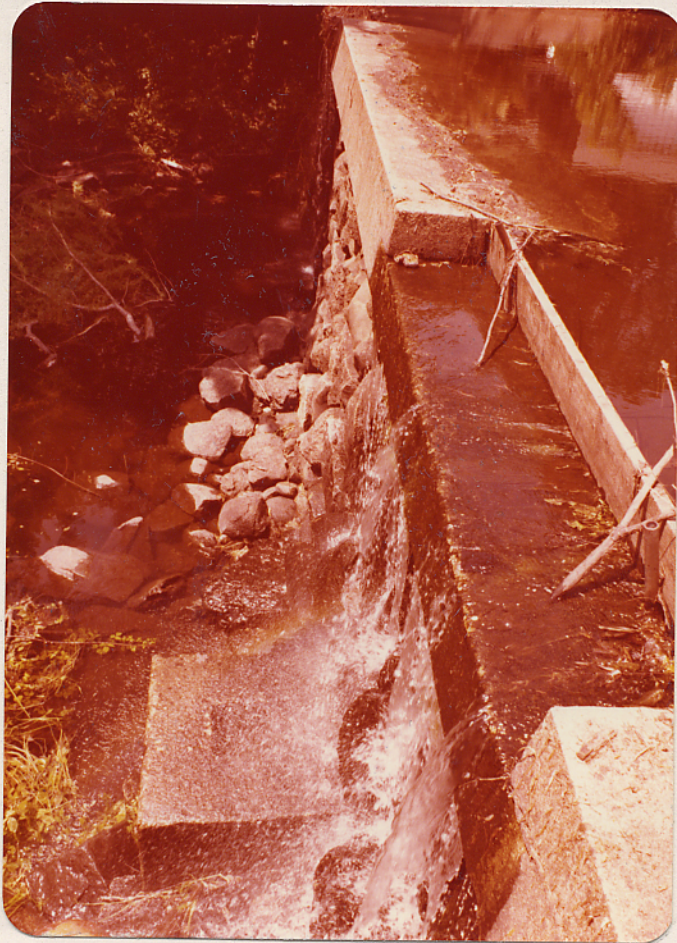
The downstream face of the dam consists of dry squared stone masonry and rubble stone masonry. The dry squared stone masonry is adjacent to the right abutment and extends along the spillway face for approximately 10 feet. Some stones are dislodged out of alignment (Photo 1). Rubble stone masonry at approximately mid-length of the spillway has bulged outward and some has unraveled out of place and fallen into the channel bed. A 1939 inspection by the NHWRB noted this same deficiency. The bulge is approximately 6 feet in height and voids due to dislodged stones are 2 to 3 feet above the channel bed (Photo 2). No leaks through the stonework were evident.

With the exception of the bulge near the center of the downstream face, the field investigation revealed no significant displacements and/or distress which warrant the preparation of structural stability calculations based on assumed sectional properties and engineering factors. The potential hazard from the bulge is not clear, particularly in light of its existence since at least 1939. Section 7 includes a recommendation with respect to this feature.

There are no formal operating records in existence for this dam. However, contact with long-time residents revealed no visual evidence of any instability during past floods. The survival of the dam during the 5 to 6 foot overtopping in 1938 provides some insight into its stability, but this incident may, however, have caused the present bulge, first noted in 1939.

2. View of displaced rock and bulge at toe of dam beneath center of spillway from right abutment (8 July 78)

(b) The cause and possible effects of the bulge in the downstream face of the dam are not known. An engineering study of this situation is necessary to insure the long-term safety and stability of the dam.

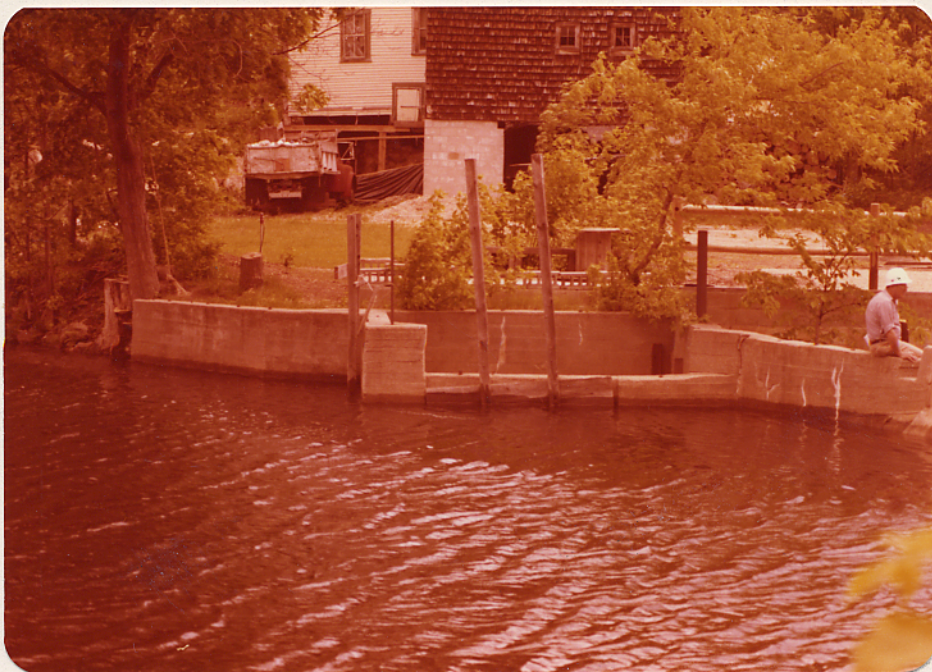
The left abutment, as shown in Photo 3, is of concrete, and overtopping flows would deflect into an open area to the east of the converted mill. A concrete outlet is integral to the left abutment and internal dimensions are approximately 7 feet wide and 11 feet long. The structure is approximately 9 feet deep. The concrete contains medium random cracking and efflorescence. The water level within the structure was approximately 1 foot below lake level on June 1, 1978. The structure has two inlets and one outlet. One inlet is on the upstream face of the structure and the other is in the right wall. The upstream inlet consists of a 4 foot by 4 foot opening. It was not possible to measure the dimensions of the right inlet. Both inlets are sealed with wood. The outlet, which has stop-logs set in place, is on the downstream end of the structure. The top of the stop-logs are 5.3 feet below the top of the structure. Due to their submerged condition, visual inspection of the stop-logs is not possible, however a representative of the owners indicated that they are 4 inches in nominal thickness. There is leakage at the inlet end of the penstock, probably due to faulty seating of the stop-logs. The wood stave penstock is in poor condition and beyond salvage. At least 50 percent of the staves are completely deteriorated (Photo 6).

3. View of outlet structure from right abutment
(1 June 78)

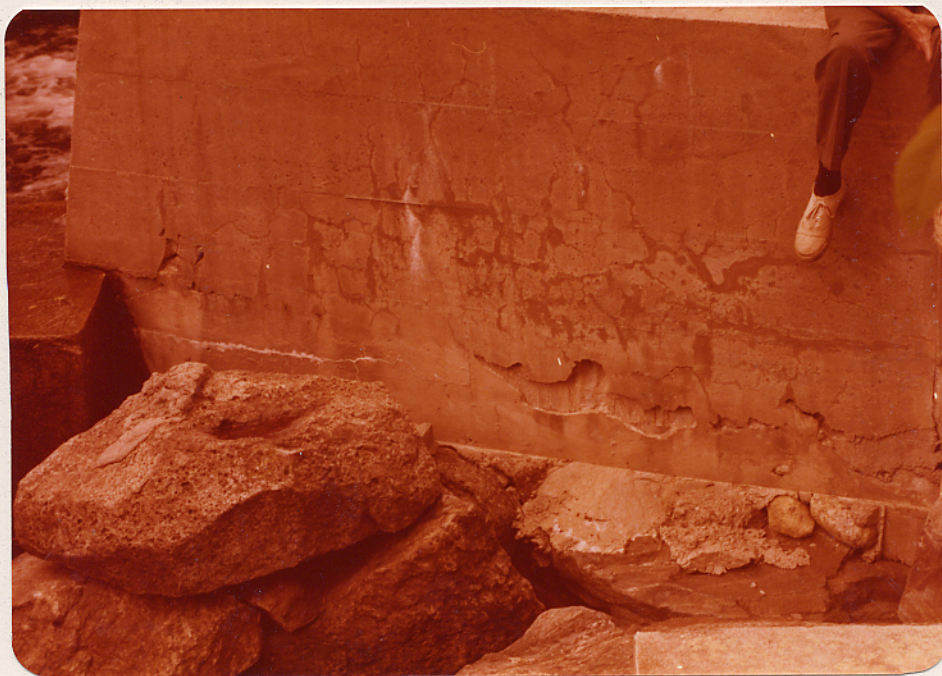
supports the balance of the abutment. This abutment has spalled with evidence of medium random cracks and efflorescence (Photo 4). Heavy boulders sloping from the channel bed to the bottom of the concrete cap preclude visual inspection of this abutment. The concrete cap on the left abutment is in fair condition. No leaks through or around the abutments were evident.

4. Detail of spalling and efflorescence on
concrete forming left abutment (1 June 78)

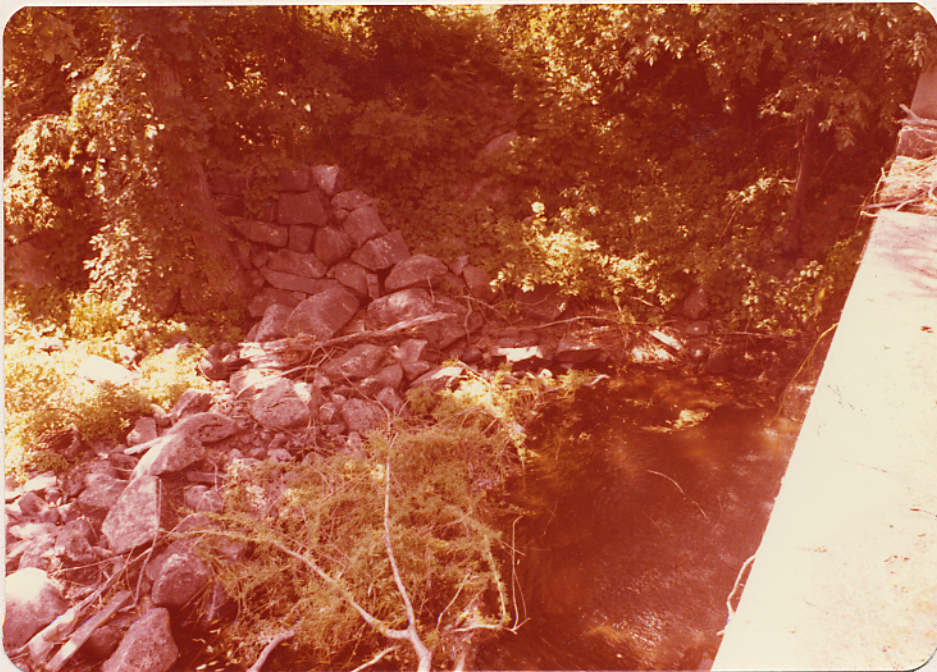
The collapsed downstream training wall on the right side (Photo 6) presents no immediate hazard to the dam or to downstream areas, but does require routine repair to channel discharge properly and to prevent undermining of the nearby road.

5. View of collapsed right training wall
from left abutment (8 July 78)

- (1) Clear all debris, particularly logs and branches, from the downstream channel.
- (2) Reconstruct the right downstream training wall.
- (3) Clean out and seal all cracks in the concrete portions of the dam, particularly the spillway, and repair all spalled areas.
- (4) Install a staff gage upstream of the dam which will provide visual readings during flood periods. These observations will provide information on future flood discharges.
- (5) Continual surveillance of the dam should be provided by the owner during periods of unusually heavy precipitation. The owner should also establish a formal system with local officials for warning downstream residents in case of emergency.

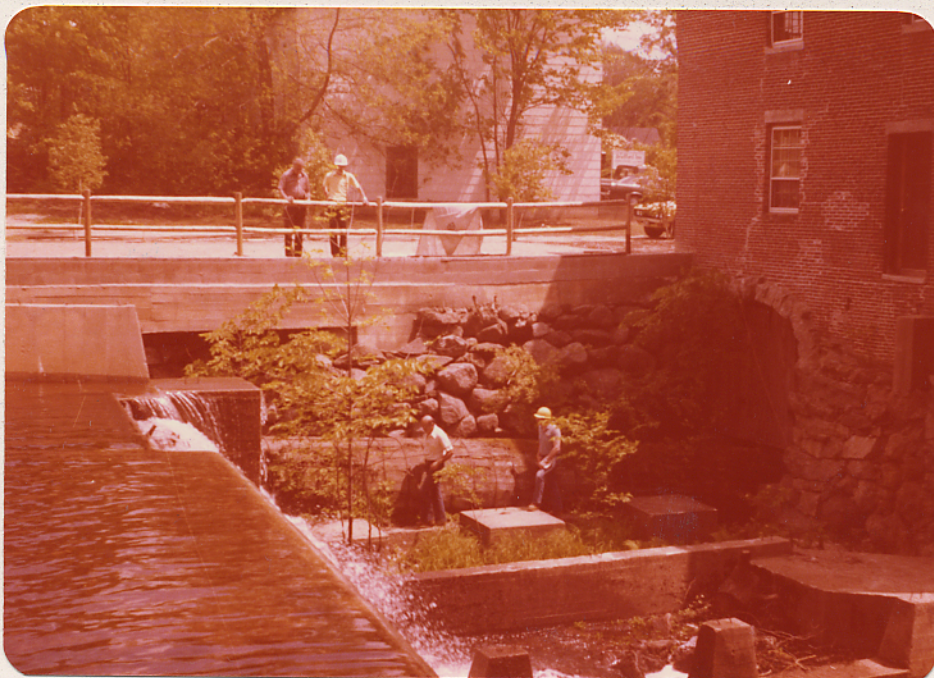
6. View of penstock from right abutment
(1 June 78)

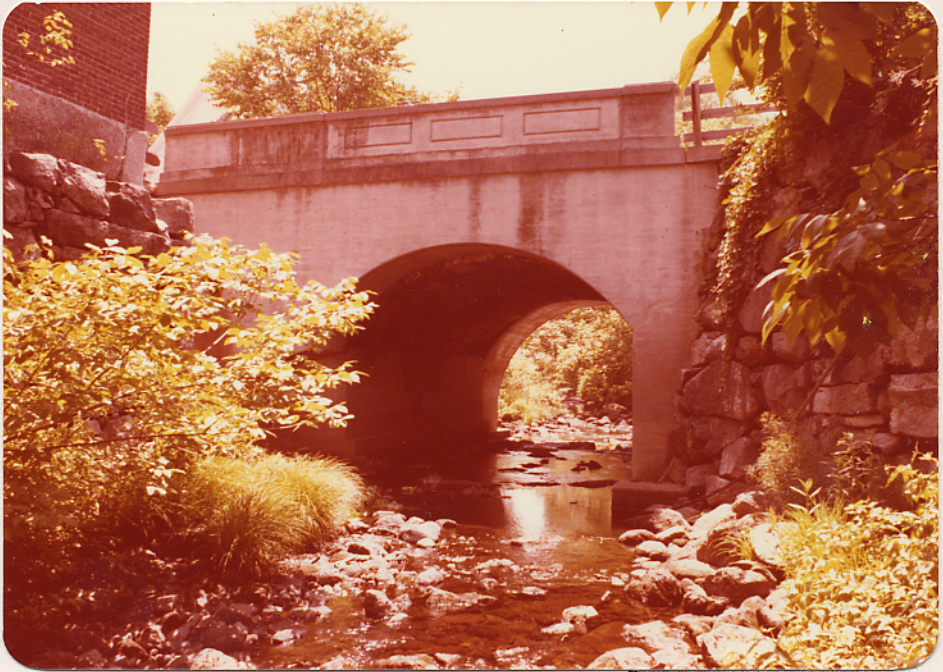
The existence of the road bridge just downstream of the dam would create significant backwaters at the dam in the event of the STF, a situation more beneficial than harmful in terms of the dam's structural stability. The bridge is a concrete arch with a width of approximately 16 feet and a maximum height of approximately 16.5 feet. The narrow, steep channel for some distance downstream virtually assures high water levels around the channel, but the lack of any significant downstream development indicates that property damage is the greatest danger.

7. View looking downstream of road bridge just below dam
